DEPARTMENT OF TRANSPORTATION

Contract #: 04-0120F4Cty: SF/ALA Rte: 80 PM: 13.2/13.9File #: 69.28**WELDING INSPECTION REPORT****Resident Engineer:**Pursell, Gary**Address:** 333 Burma Road**City:** Oakland, CA 94607**Report No:** WIR-009315**Date Inspected:** 18-Sep-2009**Project Name:** SAS Superstructure**OSM Arrival Time:** 700**Prime Contractor:** American Bridge/Fluor Enterprises, a JV**OSM Departure Time:** 1900**Contractor:** Zhenhua Port Machinery Company, Ltd (ZPMC), Changxing Island **Location:** Shanghai, China

WELDING INSPECTION REPORT

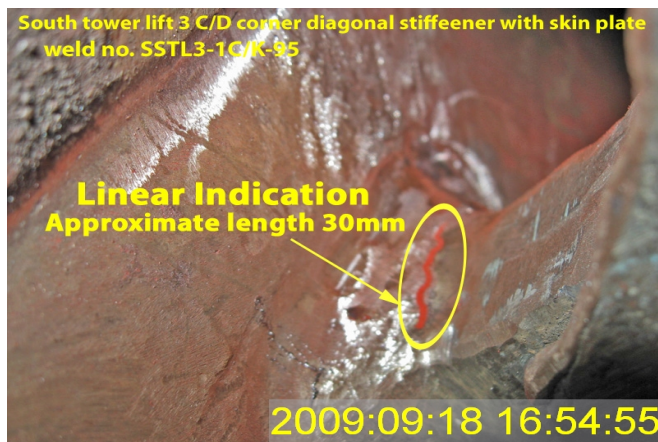
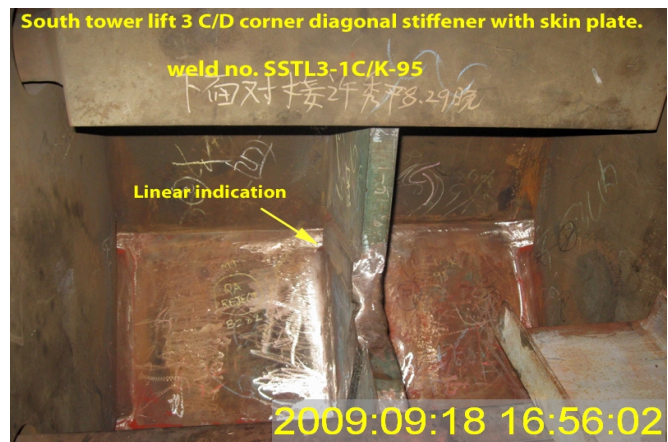
SSTL3-1C/K-95 (30 mm MT linear indication observed, incident report)

During random verification Magnetic Particle Testing (MT) of South tower lift 3 C/D corner diagonal plate with skin plate, weld SSTL3-1C/K-95 located in the Tower Bay no.10, Caltrans Quality Assurance (QA) Inspector discovered a linear indication of approximately 30mm in length. This area had been previously tested and accepted by ZPMC NDT personnel. The attached photographs provide additional detail.
